Sycamore Creek- Crego Park to Hawk Island Park

Photo 1: Looking west at N. Aurelius Road

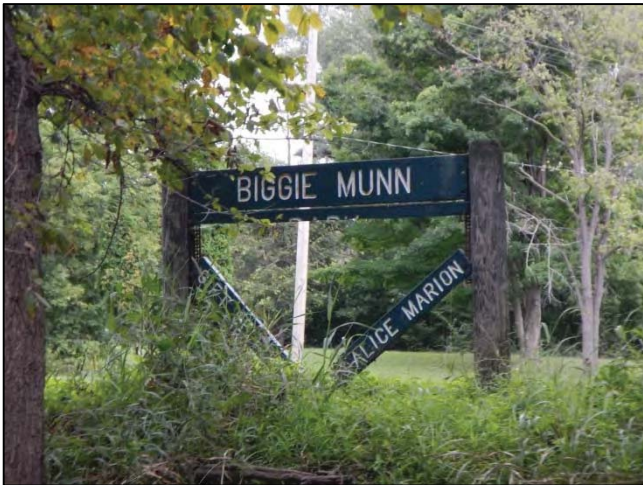
Photo 3: Broken sign at Munn Park

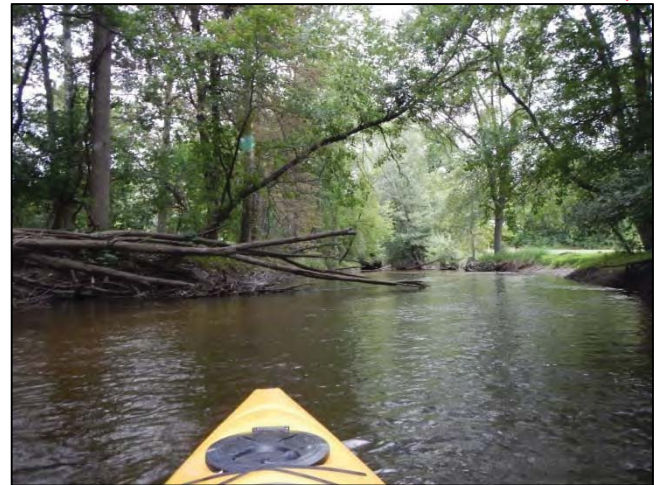
Photo 4: Looking west
